## Top Drive Guard Catch Alert

Alert

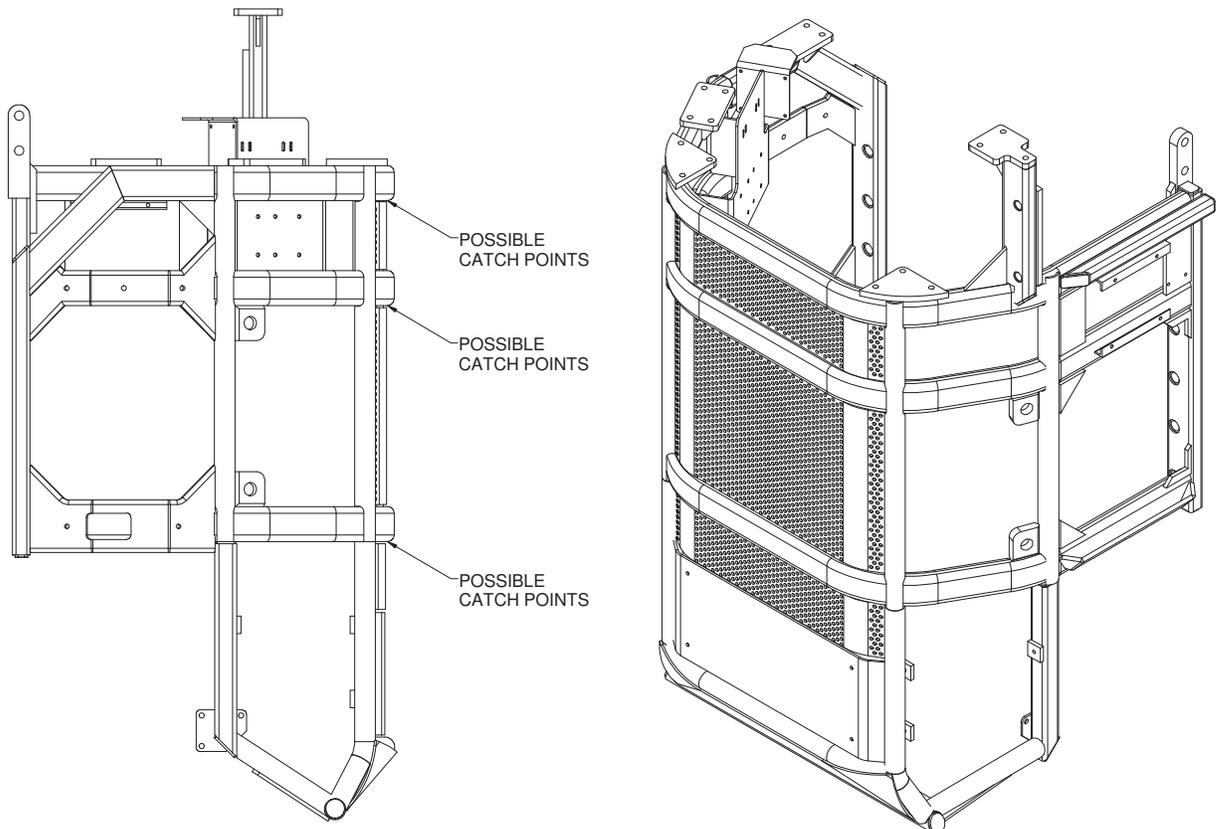
Some top drive guards contain perforated plate on the front of the guard that is recessed 1.25" from the face of frame creating a possible catch point. Should drill pipe or other tubulars make contact with the front of the top drive guard while the top drive is descending, the pipe can become entrapped on the structure of the guard.

Figure 1: Possible catch points on the top drive guard

Before lowering top drive, ensure the top drive path is clear of drill pipe or any other objects. When necessary use spotters to verify top drive path is clear. Visual and verbal communication between Driller and Derrickman is essential.

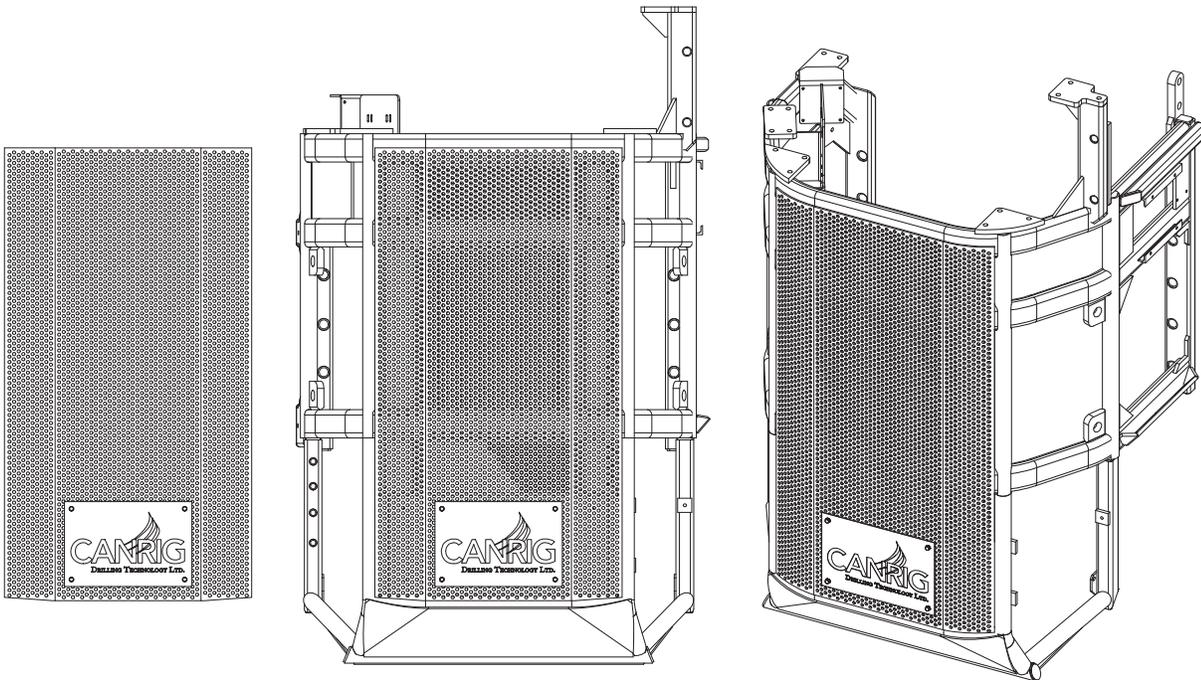
Figure 2: Modified guard included with the kit

Should preventative methods fail, a guard modification kit is available. This kit eliminates the possible catch points by providing one continuous surface free from any recesses. To install the kit, the existing perforated plate will need to be cut out and removed in the locations described on Figure 3 on page 3, and a new replacement plate will have to be weld in. Contact RIGLINE 24/7™ Support to purchase the components under kit AY23335.

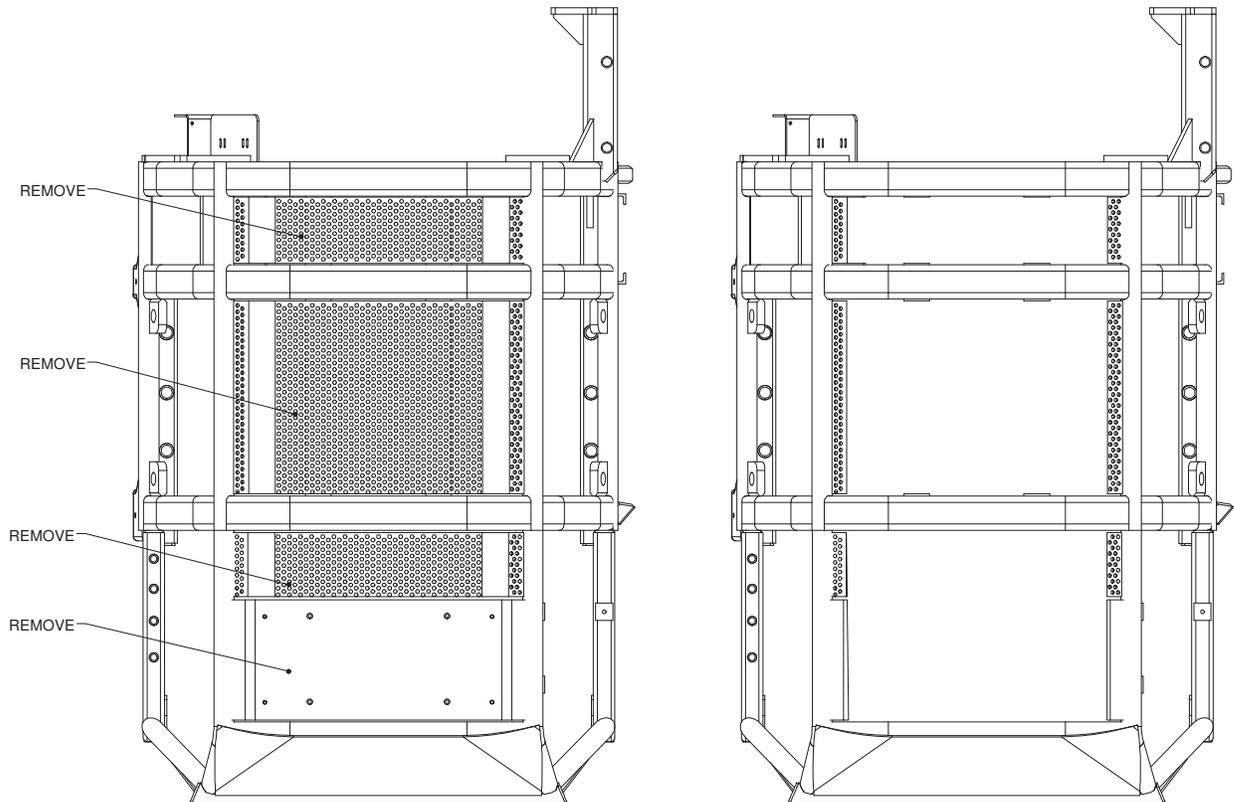
Figure 3: Remove existing plates

1. Cut out existing perforated plate and nameplate mount as shown on Figure 3.

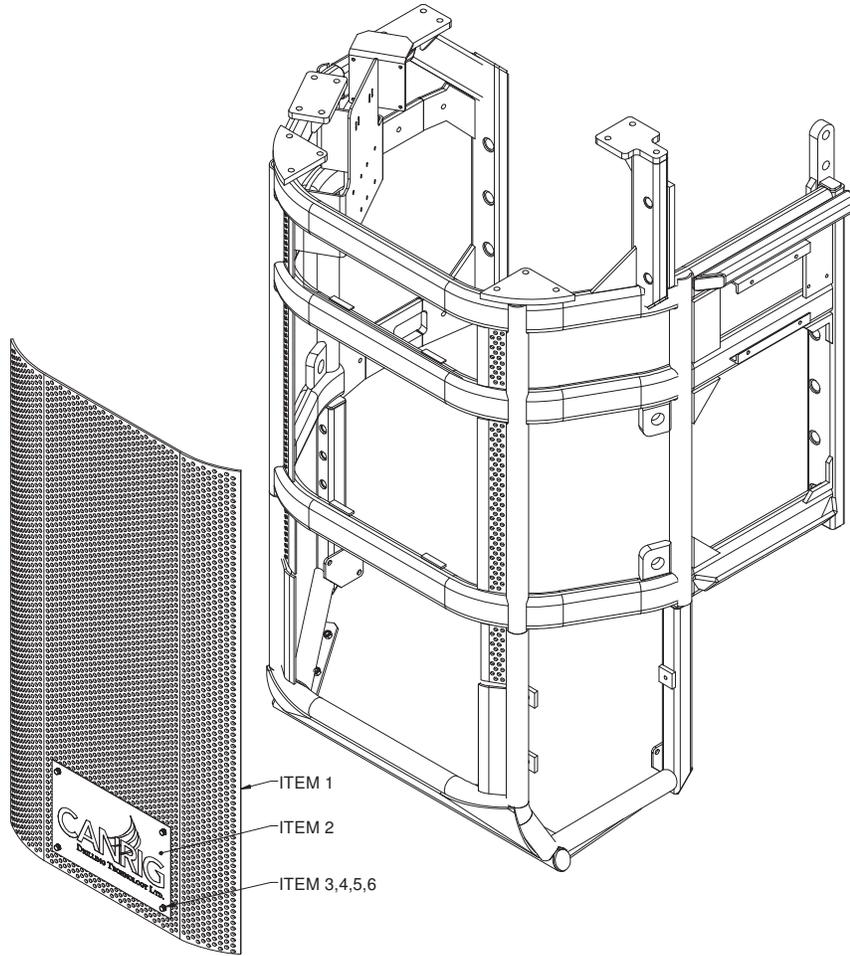
Figure 4: Top Drive Guard Cover Kit

- Place perforated guard cover (item 1 on Table 1) onto surface of existing cage. Make sure bottom of perforated plate (determined by the nameplate mounting hole location) is flush with the pipe at the bottom of the cage to ensure proper fit. See Figure 4.

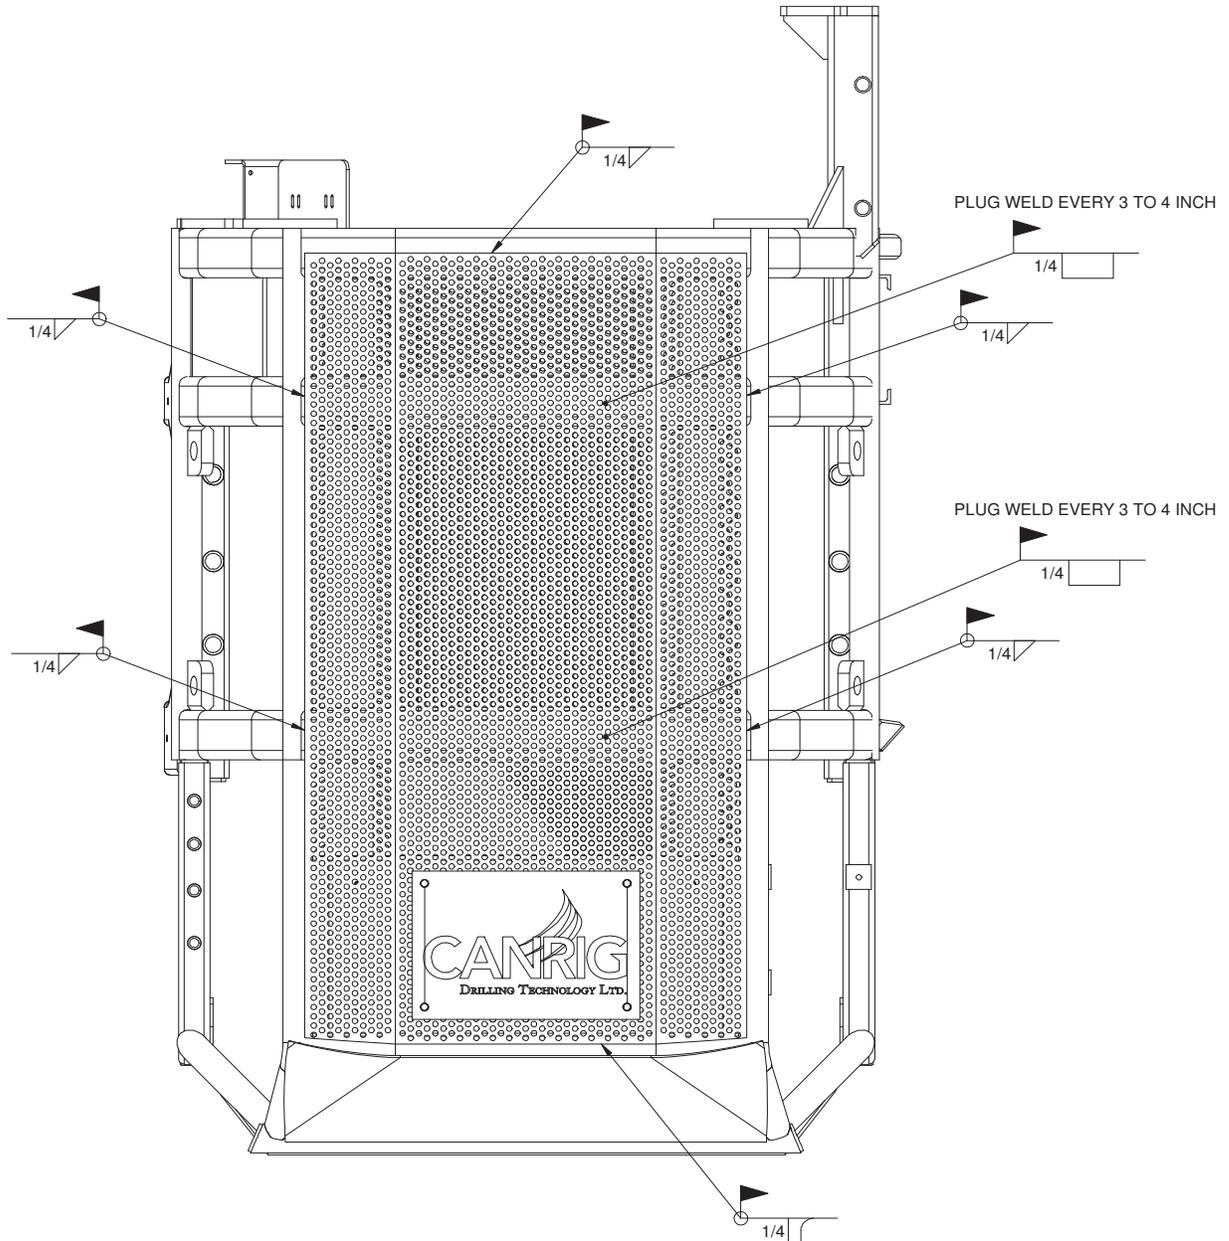
Figure 5: Welding instructions

- Weld Item 1 to existing tubing of cage frame as shown on Figure 5 using E7018 welding rod or equivalent per the welding method used.

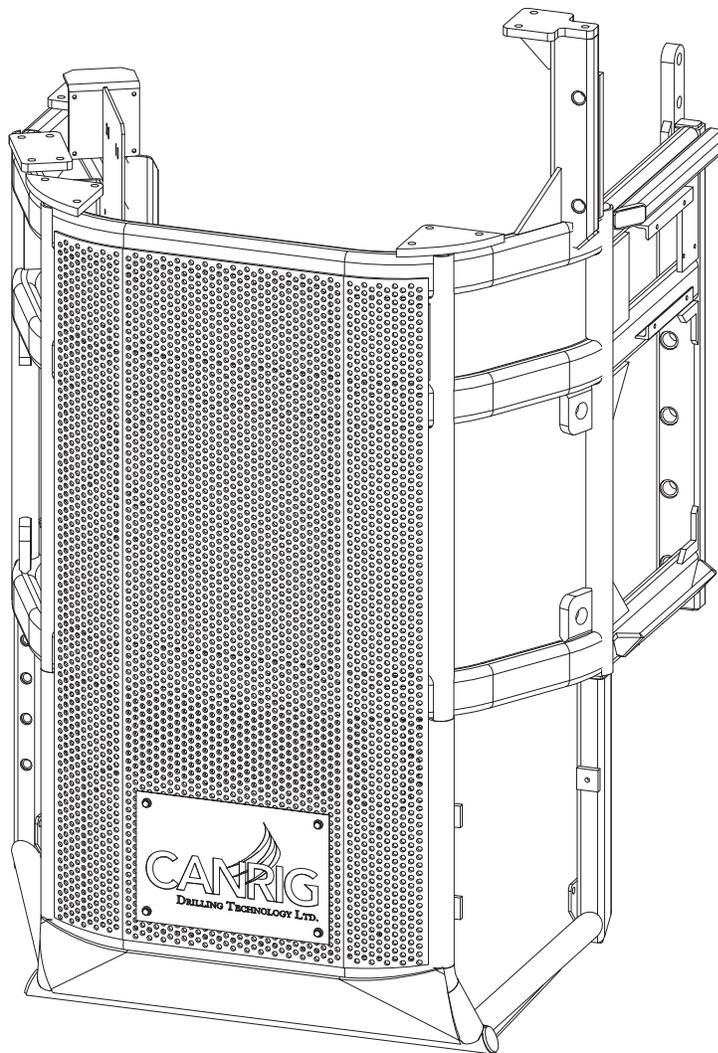
Figure 6: New perforated plate after installation

4. All bare steel will need to be painted to minimize the possibility of rusting.
5. Locate nameplate (item 2) with the tapped holes provided. Apply Loctite 242 or equivalent to 3/8" bolts (item 3) and use to secure nameplate in conjunction with lock washers (item 4). Torque 3/8" bolts to 40 ft-lbs per Canrig Engineering Specification ENG 725.
6. Safety wire 3/8" bolts using 1/16" diameter wire rope (item 5) and 1/16" oval sleeve (item 6) to prevent loosening of bolt and retaining bolt head in case of failure per Canrig Engineering Specification ENG 701.
