Change Bulletin

No: CB018

Description: CDS Mud Saver Valve Spring Pin Replacement and Field Repair

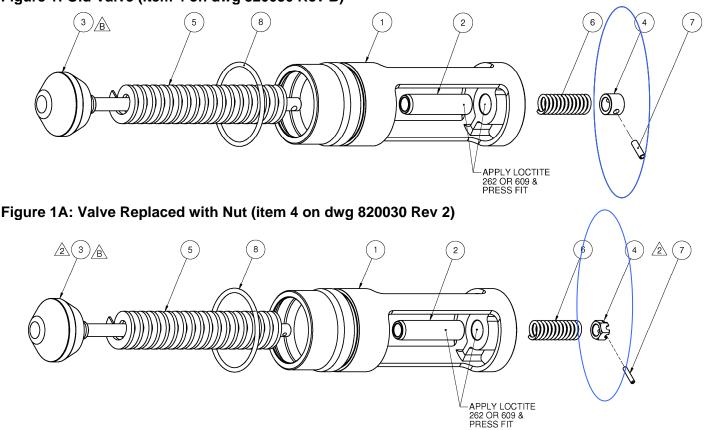
Figure 1: Old Valve (item 4 on dwg 820030 Rev B)

On the Casing Drive System Mud Saver Valve (MSV), the spring pin broke while in service. This allowed a plunger to be driven up into the gooseneck of the swiv el, and eventually it was pumped down-hole inside the drill p ipe. The issu e is that the slotted spring pin can work its w ay out and/or break, which in turn releases the valve spring retainer (it em #4 in Figure 1). This allows the plunger to go up into the upper top drive load p ath while releasing trap ped pressure in the casing. If the plunger gets stuck there, when the CDS is removed, the plunger can be pumped down inside the drill pipe.

To correct this issue the mud saver valve spring retainer (#820034) has been replaced with a slotted hex nut (#860148). Also the slotted spring pin (item 7 on drawings below) has been changed from a \emptyset 3/16 x 5/8 pin to a \emptyset 1/8 x 5/8 pin, see figures 1 and 1A below.
