Technical Bulletin

No: TB042

Description: 6 Ton Single Joint Elevator Load Latch Inspection and Repair

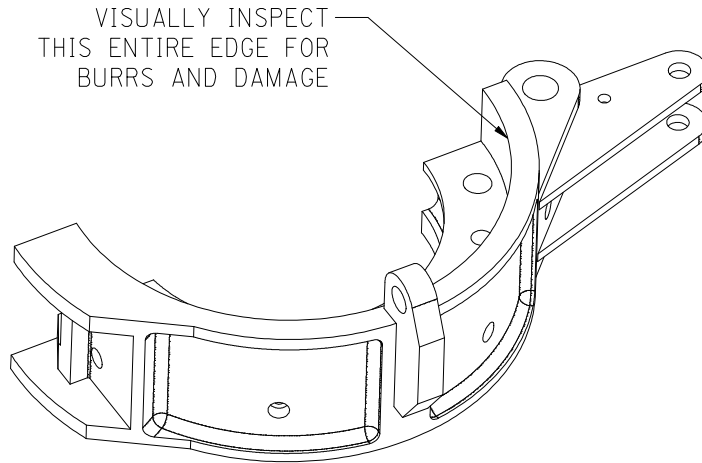
Figure 1, Left Body Half Inspection

Burrs on the edge of the left body half have been found to impede proper function of the load latch. Visually inspect the edge of the body half for any burrs or minor damage; see Figure 1 for clarification. If burrs or minor damage are present, repair by blending them out with a flapper wheel. For any damage considered not minor, contact the local TESCO Sales and Service Representative before proceeding.

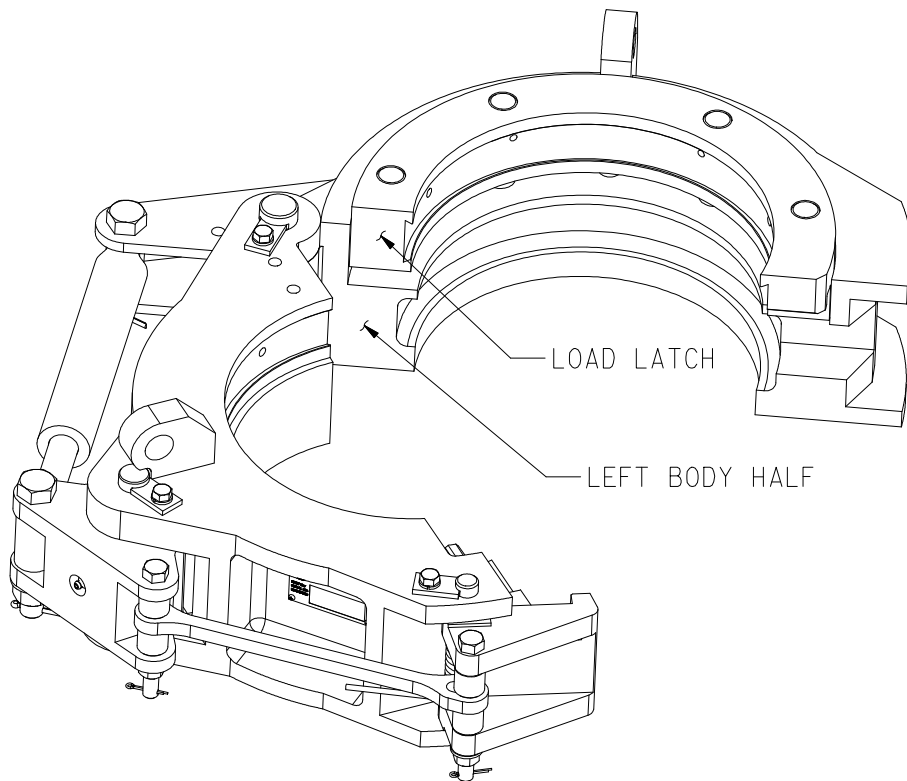
Figure 2. Load Latch and Left Body Half Identification

Another cause of this problem has been attributed to the protrusion of the load latch past the left body half near the main hinge pin as shown in Figure 2. When the elevator is closed, this results in an interference between the load latch and the right body half which impedes the free operation of the load latch. If this is the case, measure the amount of the protrusion as shown in Figure 3 by using a vernier depth gauge and as a repair, mill the protrusion distance plus 0.030" (0.76 mm) off of the face of the load latch. As an example, if the protrusion was measured to be 0.015" (0.38 mm), then 0.045" (1.14 mm) should be machined off of the load latch. Use Figure 4 to communicate the required repair. Contact the local TESCO Sales and Service Representative before proceeding if measured protrusion distance exceeds 0.120" (3.05 mm).
