PRODUCT: TM-80, 110"

DATE: May 06, 2011

SUBJECT: Inspection of Main Boom Pin Tube and Support Gussets

SERIAL NUMBERS: All TM-80, 110" Torq-Matic Wrenches

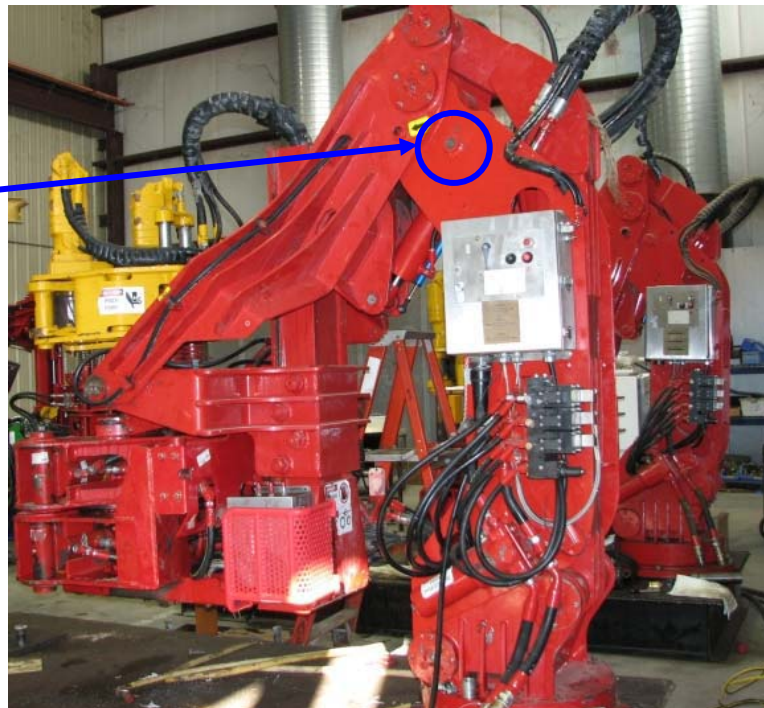
Figure 1 shows the location of the pin tube on the main boom. Two halves of the pin tube are welded to the insides of the main boom side plates. The horizontal cylinder is secured between the tubes with a 1 1/4" pin and is used to extend the wrench tong assembly over the well.

Main Boom Pin Tube

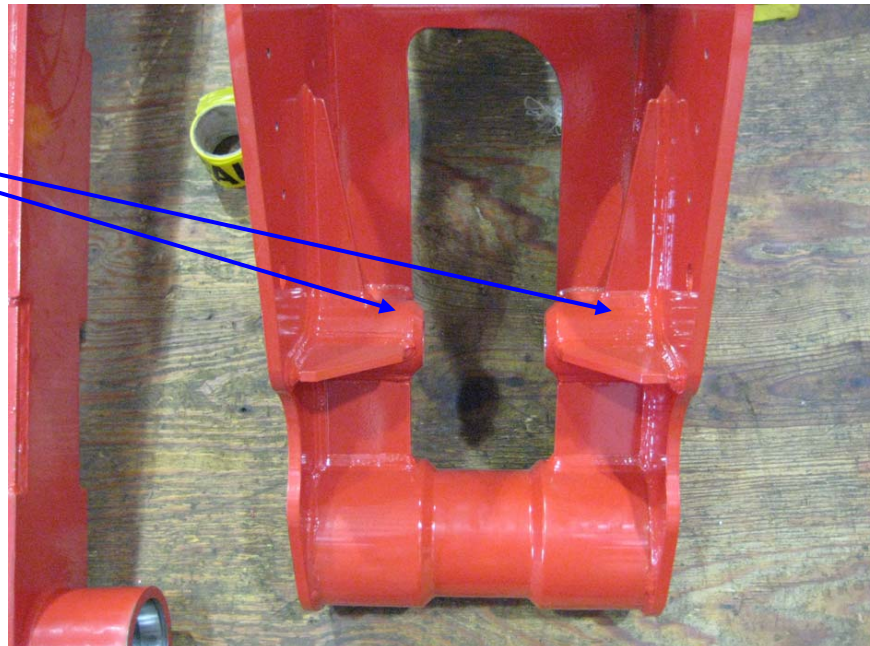
Figure 2

1. Conduct inspection of the wrench following the below steps.
 - a. Extend the wrench out far enough so that the vertical can be fully lowered down and carefully set on the floor, without putting stress on the vertical cylinder.
 - b. Disconnect power. Follow local tag out and lock out procedures. Remove any valve hand controls if installed.
 - c. View main boom from underneath with flashlight and inspect main pin tube and supporting gussets for cracks in the welds. Clean the area around the pin tubes and support gussets if necessary for better visibility
 - d. Using a step ladder and flashlight, perform similar inspection from above main boom.
 - e. Inspect pin tube and weld from the outside on both sides for cracks or evidence of buckling.
 - f. Figures 2 and 3 below indicate the areas of inspection.

Pin Tubes

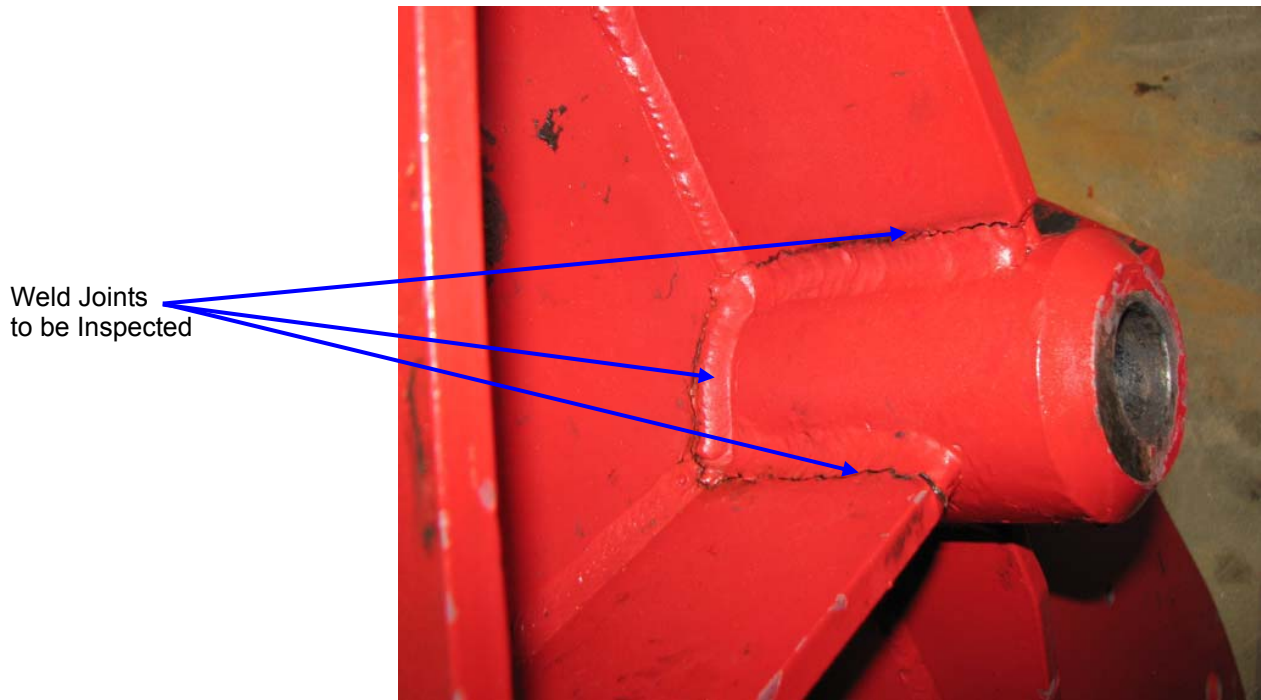
Figure 4

Examination of the weld joints revealed voids between the support gussets and pin tubes, poor penetration of the weld into the gusset material, and lack of weld fusion with the pin tubes. Canrig estimates that the inferior quality of the welds could have reduced the maximum allowable stress in that area by as much as 70%. Because the weld deficiencies were hidden underneath the weld, they

- g. Evidence of cracking at the weld joints between the pin tube and support gussets is indicated in Figures 4 and 5 below.

2. If you find evidence of cracking at the weld joints similar to that depicted in the above images, contact the Canrig Service Support Department immediately for an assessment. Contact information is provided below.

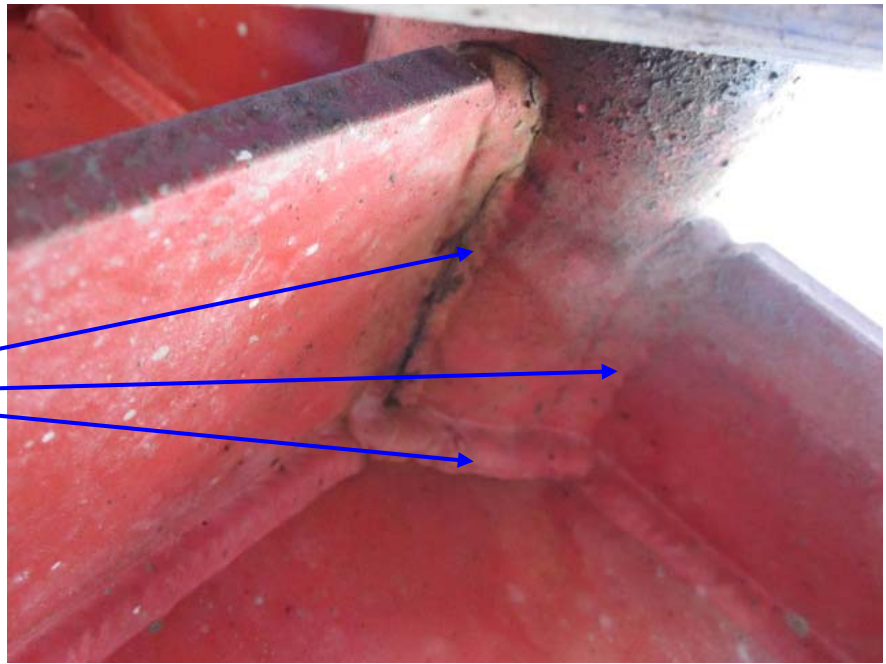
Figure 5

Weld Joints
to be Inspected
