# Change Bulletin

No: CB044

Upgrades to TESCO Cementing Plug Launching System

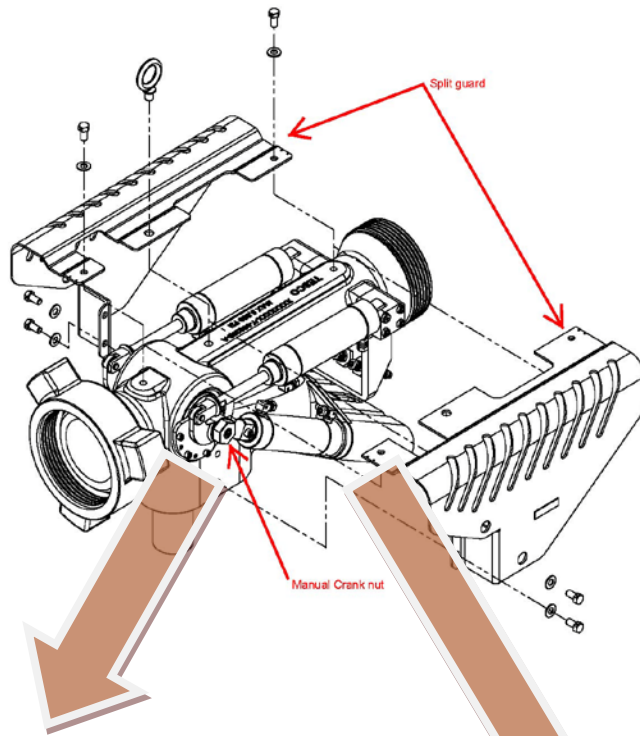
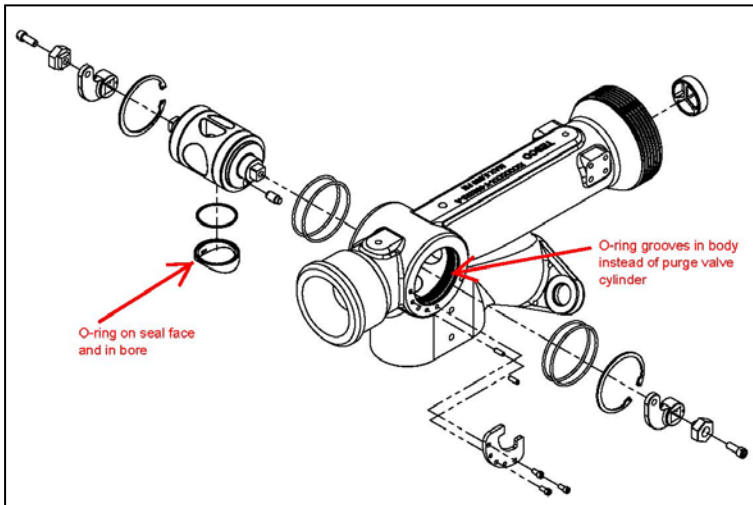
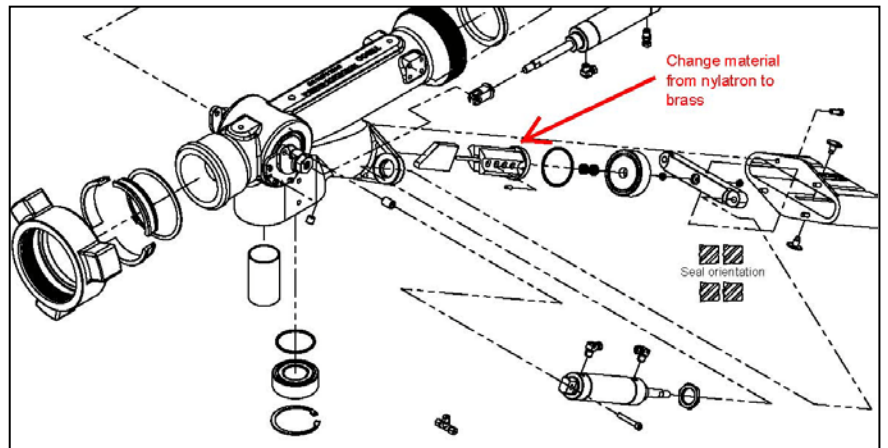
During several field trials of the TESCO Cementing Plug Launching System (CPLS), a number of deficiencies were identified with the Ball Launching Mechanism (BLM). Design changes were made and implemented to address these deficiencies. The following is a summary list of the design changes that were made (also see diagrams below):

1. The O-ring grooves that were in the purge valve cylinder were moved to the BLM body. This reduced the possibility that the O-ring may get cut during assembly.

2. The guard was split so that it can be removed without disassembly of the BLM.
3. The air lines in the BLM and control panel were replaced with brake lines and fittings to ease maintenance and reduce the possibility of “kinking” the lines.

4. Manual crank nuts were added to the purge valve to facilitate the opening and closing of the purge valve with a wrench.
5. Slots were added to the ball cages to enable the operator to rotate the ball cage with a special wrench so that it engages in the proper orientation. A dual purpose wrench was added to the equipment kit for this purpose.

6. An O-ring has been added to the sealing face and to the bore of the purge valve seal to enable the purge valve to seal at low pressure (300 psi) and at high pressure (5,000 psi).

7. The material of the blade guide was changed from Nylatron to Brass. The nylatron absorbed water and swelled out, making the assembly difficult and causing the blade to stick.

**None. This bulletin is for information only.** All BLM's already produced to date had been reworked to include the changes described above.
