Safety Bulletin			 	Tesco Corporation 5616 – 80th Avenue SE Calgary, Alberta, Canada T2C 4N5 Tel: 1-877-TESCO-77 (North America) Tel: 1 (713) 359-7195 (AMSS 24-hour support) Tel: 1 (713) 359-7295 (International) Email: bulletins@tescocorp.com www.tescocorp.com www.tescoparts.com
No: SB062	Rev: 0	Date: March 12, 2013		
Over-Stressed Torque Restraint On 350-EXI-600 Top Drive

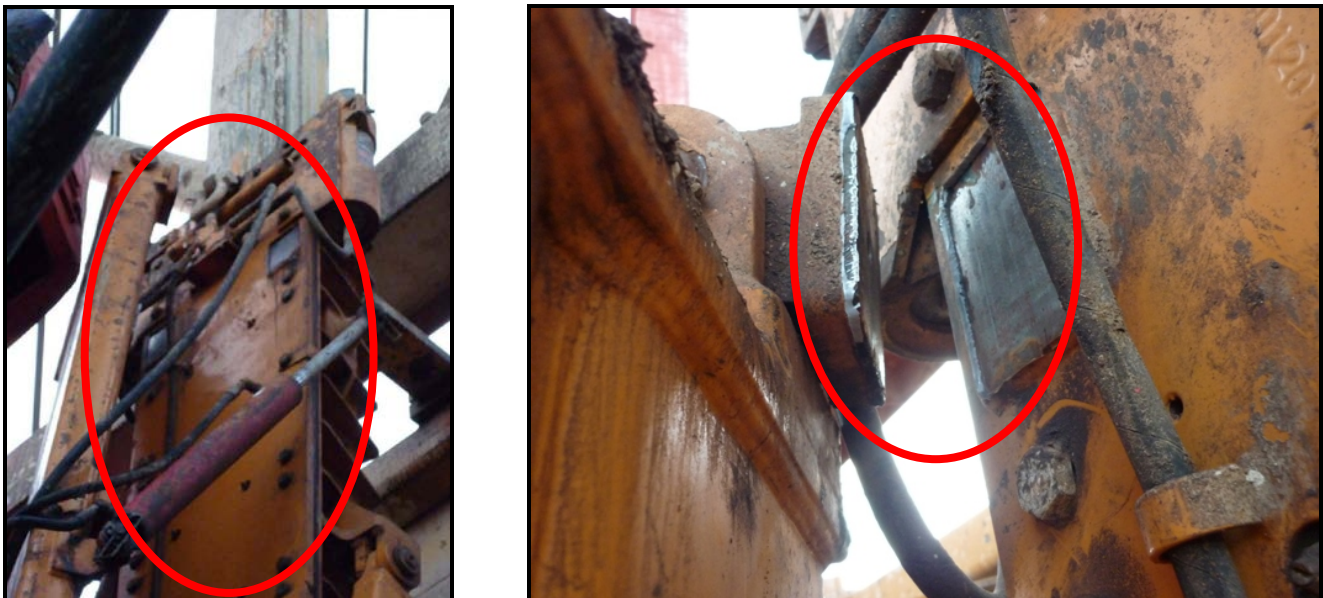
Two issues have been identified where the lugs on the TESCO 350-EXI-600 Top Drive torque restraint can become over-stressed and fail during operation.

Issue 2: An investigation has also found that a lack of fusion between the weld material and the clevises was a significant contributing factor in this failure. TESCO identified a single vendor that had provided faulty torque bushing products since 2010. As a field retrofit procedure, TESCO is recommending to grind out the existing welds and replace them with a revised weld. A revised drawing of the front plate (810331 Rev4) has been issued to assist in the rework of all existing units.

Figure 1: Upper clevis weld of EXI torque bushing front plate sheared off from top drive

Notwithstanding the fact that this incident did not result in significant damage, if a similar failure were to occur while rotating, severe damage (up to and including injury or death) could result from the top drive rotating unrestrained in the mast. TESCO advises that the top drive should not be used to provide rotation (drilling, torqueing of connections, etc.) until such time as a repair is undertaken.

1. The welds attaching the clevises to the torque bushing front plate (TESCO part number 810331, Figure 2) are to be fully ground out and replaced with 3/4" fillet welds under an approved weld procedure for A514 grade material (Quenched and Tempered 100 ksi yield plate) as specified in drawing 810331 Rev4.
2. Ensure that the rework is performed by a qualified welder using an approved weld procedure specification suitable for A514.
3. New cylinders (TESCO part number 0926) are to be installed with cylinder stop tubes (TESCO part number 5012642) to prevent the cylinders from locking when fully extended.
