Safety Bulletin			  TESCO [®] Tesco Corporation 5616 – 80th Avenue SE Calgary, Alberta, Canada T2C 4N5 Tel: 1-877-TESCO-77 (North America) Tel: 1 (713) 359-7195 (AMSS 24-hour support) Tel: 1 (713) 359-7295 (International) Email: bulletins@tescocorp.com www.tescocorp.com www.tescoparts.com
No: SB100	Rev: 0	Date: November 2, 2016	
Dropped Object from ESI Top Drive Blower Motor			
<input type="checkbox"/> Internal Use Only <input checked="" type="checkbox"/> External Use		<input checked="" type="checkbox"/> Mandatory <input type="checkbox"/> Recommended

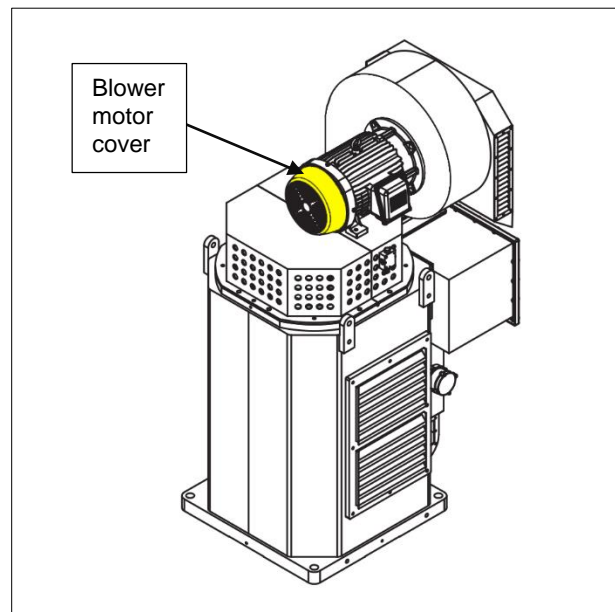
Figure 1: Motor cover

A dropped object incident was reported in August 2016 which involved falling debris from the blower motor’s metal cover on an ESI Top Drive electric motor assembly. This resulted from the disintegration of the metal cover due to long-term wear on the blower motor. This was an isolated incident with no reported injuries to rig personnel. Tesco is currently conducting an investigation to ensure that secondary retention for the blower motor meets or exceeds DROPS recommendations as per Tesco’s Dropped Object Prevention Program. Further information will be provided in a later revision of this bulletin after a thorough investigation has been conducted with our customer’s QHSE team.

2. The secondary retention mentioned in Step 1 above does NOT contain the blower motor's metal cover if it disintegrates. As such, Tesco recommends visual inspection of the metal cover for cracks, damage, or any other signs of deterioration. If any signs of deterioration are identified, remove the metal cover and fasteners, and then contact a local Tesco representative immediately.
