Technical Bulletin

No: TB062

Description: HMI Swivel Body 180° Rotation to avoid interference with extend frame system

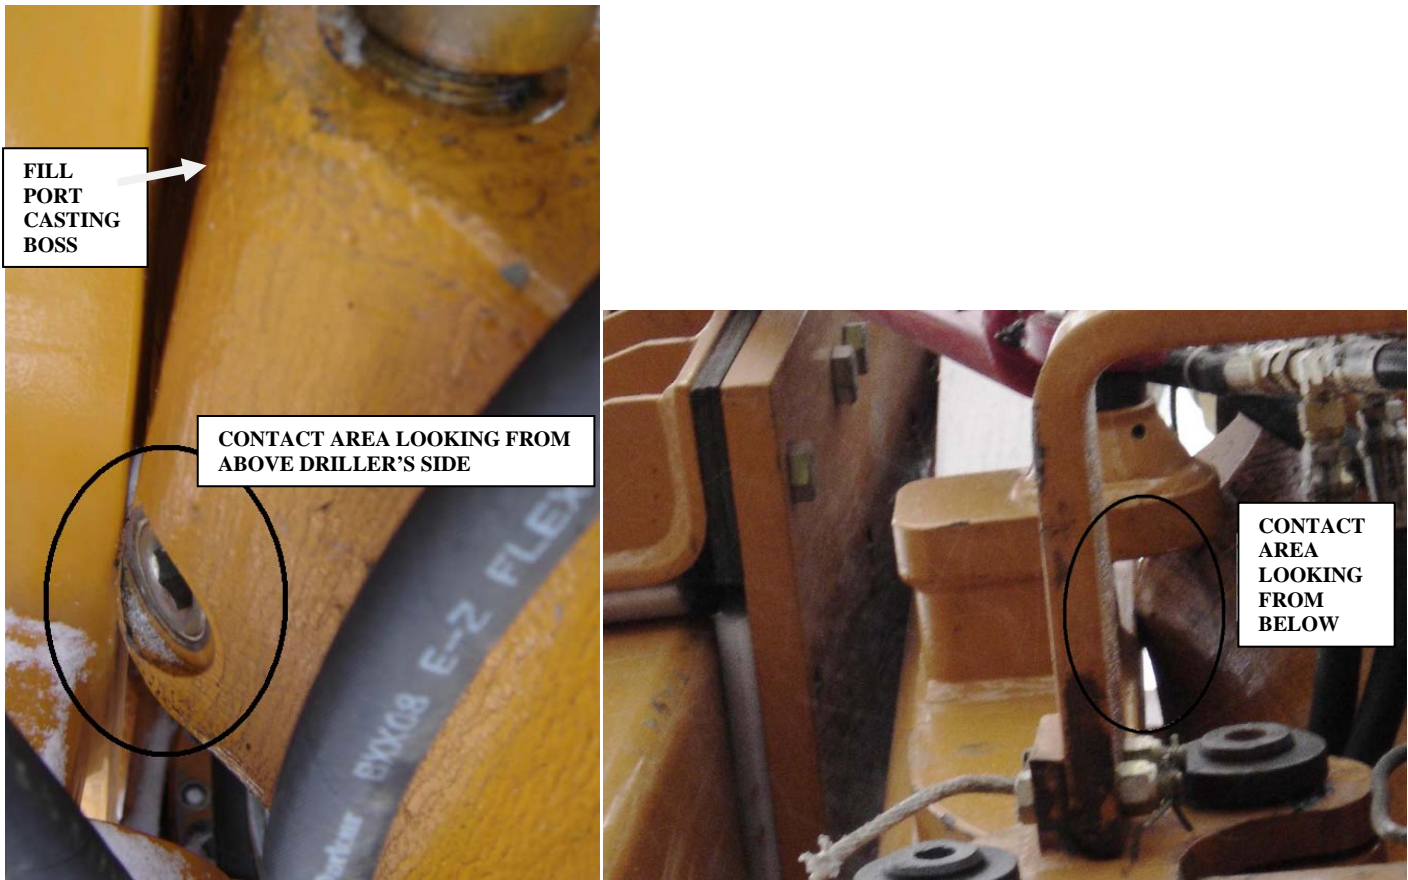
Figure 1

Incidents have occurred at rig-up where the swivel body was found to interfere/collide with the extend frame arm when Top Drive is brought back from extended to its retracted position against extend frame assembly. The interference occurred between Driller's side extend frame arm and the "fill port casting boss" of the swivel body (see Fig. 1 photos below).

(a) Interference seen from above

(b) Interference seen from below

- This interference can cause misalignment/offset between Top Drive quill centerline and center of drill hole and can lead to undue stress on swivel bearing.
- The subsequent incident investigation identified improper swivel body orientation at assembly. Specifically, the swivel body must be installed with the fill casting boss towards the front of the Top Drive which positions the fill casting boss opposite to the extend frame assembly.
- In order to eliminate collision or interference between the swivel body and extend frame arm, the swivel body must be rotated 180 degrees around its axis.

1. Evaluate if there is any interference or collision between swivel body and extend frame system at full retracted Top Drive position. If interference or collision is detected, make provisions to rotate swivel body 180 degrees maintaining same initial position for bonnet and gooseneck.
2. Complete an inspection of the extend frame system and exercise extend function several times. Ensure that no interference or collision occurs when Top Drive is fully retracted against extend frame system. Visually inspect equipment for signs of impact damage, and check for excessive play in cylinder rod ends. Rod ends with more than 1/32" of free play in any direction are considered worn beyond service limits and should be replaced.

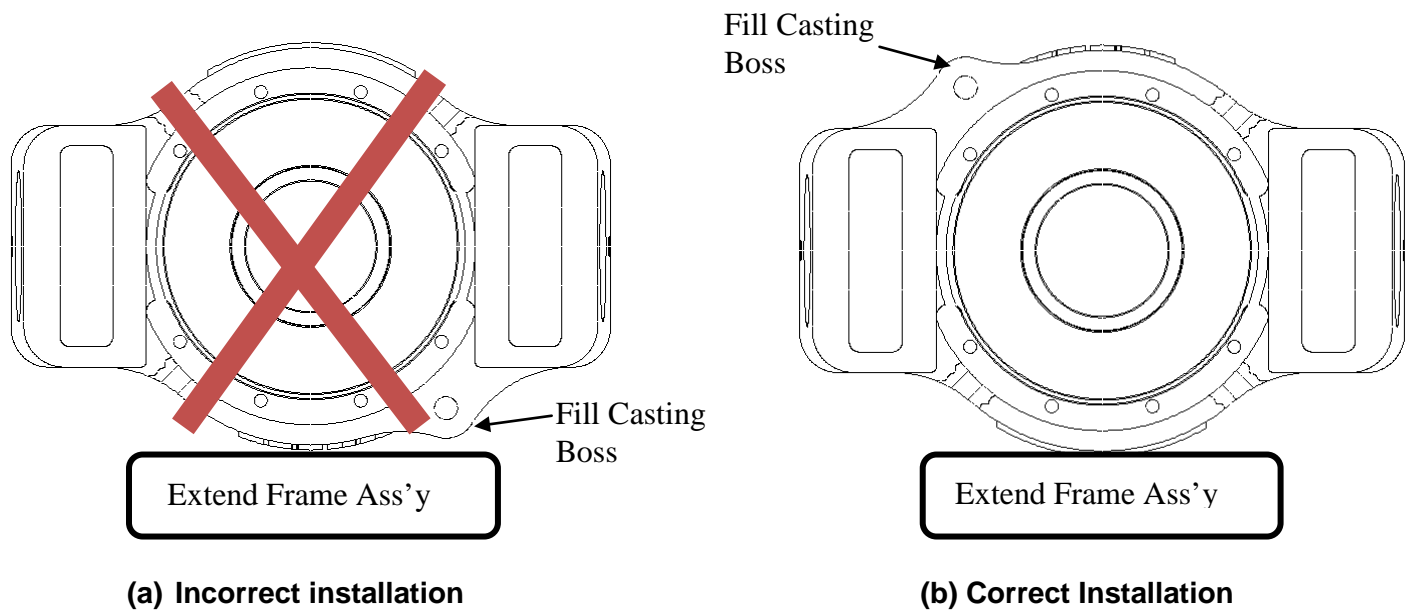
Figure 2

Fig. 2a shows the INCORRECT swivel body installation, and Fig. 2b shows the CORRECT installation of the swivel body.
