Technical Bulletin

No.: TB077

250-HMIS-475 Quill Fatigue Crack

Tesco Corporation
3993 W. Sam Houston Pkwy N., Suite 100
Houston, Texas.77043
Tel: 1-877-TESCO-77 (North America)
Tel: (713) 359-7295 (International)
www.tescocorp.com
www.tescoparts.com

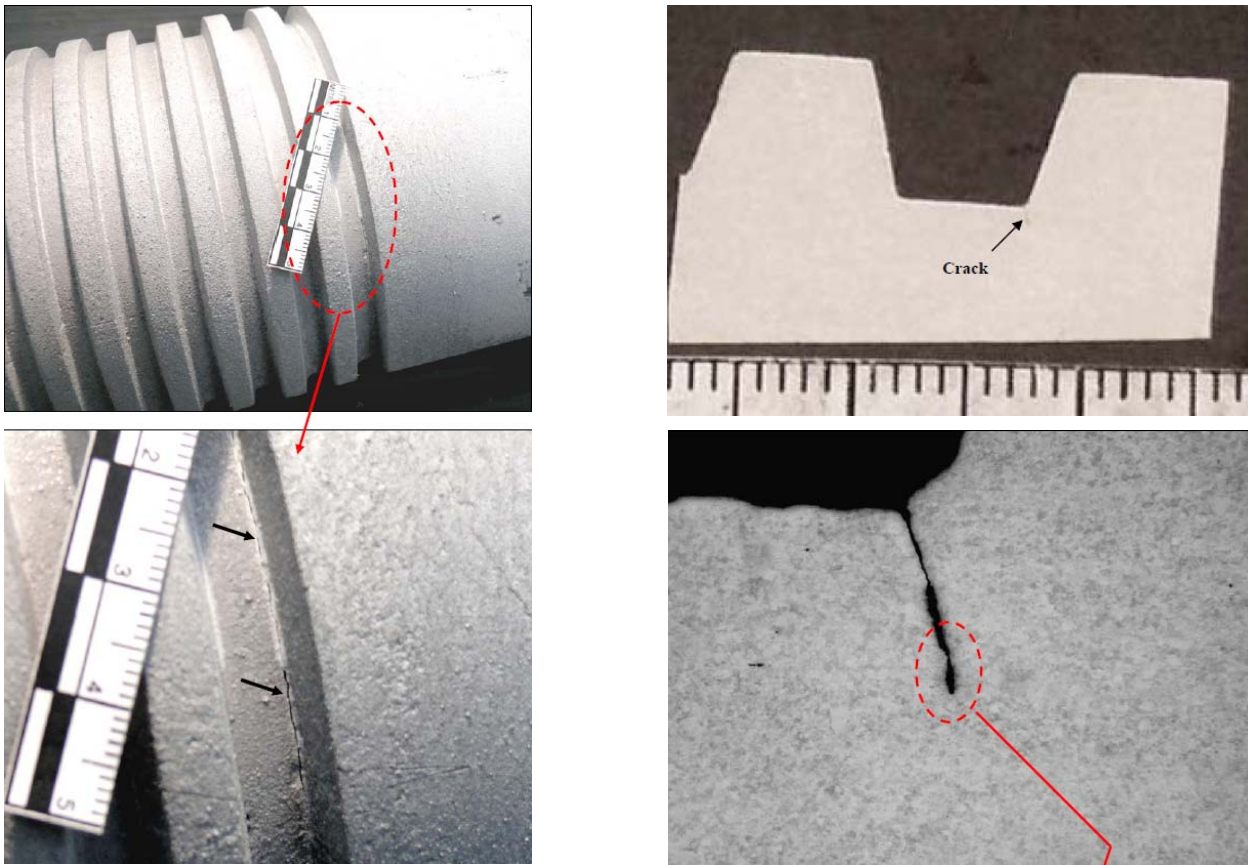
TESCO's 250T HMI top drives experience the highest level of stress of any of our top drive units. This is particularly true in North America, where our customers continue to push the limits of our equipment as they drill ever more difficult directional and horizontal wells. TESCO has received reports of cracks in the root of the lower load nut grooves on a number of 250T HMI quills. In most instances these cracks have been discovered during routine (250 day) inspections. One instance was reported in which the damage from a crack has resulted in fluid loss during operation. No instances of quill separation have been reported to date. Figure 1 shows the location of a typical crack.

Figure 1 - Example of crack indications and section view of crack

Quills that have experienced a crack were sent for both metallurgical analysis and for an assessment of crack initiation/propagation mechanism. The results of these third party analyses suggest that the cause of the crack is not related to a material (metallurgical) defect, but is the result of fatigue.

An engineering review of the design has been initiated and TESCO is currently working to qualify a modification to the load nut groove whereby the radius of the sharp corner in the root of the groove is increased and the stress concentration factor is reduced resulting in increased fatigue life performance.
