<b>Technical Bulletin</b>			 	Tesco Corporation 5616 – 80th Avenue SE Calgary, Alberta, Canada T2C 4N5 Tel: 1-877-TESCO-77 (North America) Tel: 1 (713) 359-7195 (AMSS 24-hour support) Tel: 1 (713) 359-7295 (International) Email: <a href="mailto:bulletins@tescocorp.com">bulletins@tescocorp.com</a> <a href="http://www.tescocorp.com">www.tescocorp.com</a> <a href="http://www.tescoparts.com">www.tescoparts.com</a>
<b>No: TB083</b>	<b>Rev: 0</b>	<b>Date: 08 July 2011</b>		
<b>Field Upgrade for 150 Ton Torque Restraint to Add Reinforcing Gussets</b>

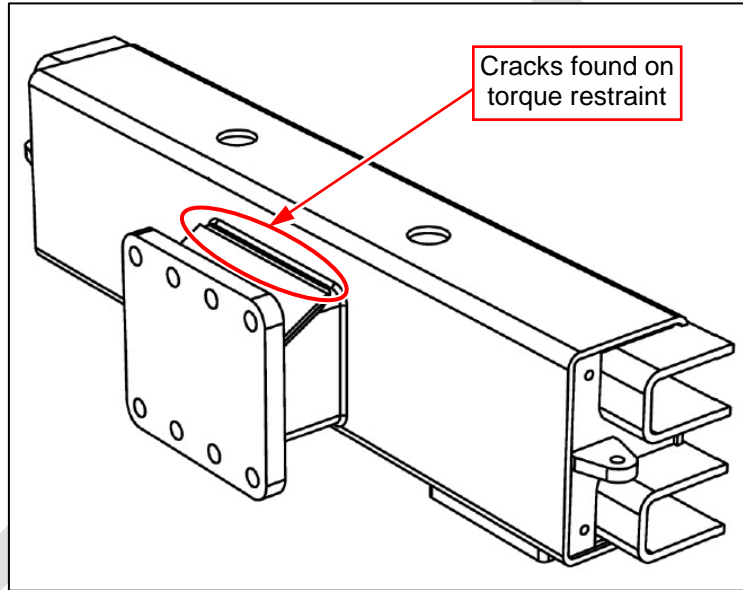
It was found that the 150-ton torque restraint used on TESCO 150-EMI-400 Top Drives was subject to cracking around the sides of the torque restraint during transportation.

To prevent future occurrences of cracking on the torque restraint, TESCO developed a work instruction that describes the procedure to add reinforcing gussets to the torque restraint.

Ensure customers using the TESCO 150-EMI-400 Top Drive have added the reinforcing gussets to the torque restraint.
