Tesco Corporation **Technical Bulletin** 5616 - 80th Avenue SE Calgary, Alberta, Canada T2C 4N5 No: TB085 Rev: 0 Date: 29 July 2011 Tel: 1-877-TESCO-77 (North America) Tel: 1 (713) 359-7195 (AMSS 24-hour support) Tel: 1 (713) 359-7295 (International) Improper Build Procedures Email: bulletins@tescocorp.com Found on 37C "A" Cables www.tescocorp.com TESCO www.tescoparts.com

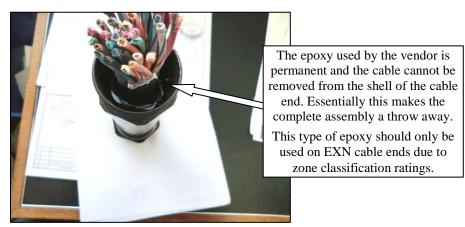
Permanent epoxy was used in the back end of the 37C cable end (Figure 2). Using this permanent epoxy essentially makes the cable end irreparable, and upon any issues, the end will need to be cut off and replaced. TESCO's standard assembly for the 37C "A" cable uses a silicon based gel that supplements water-proofing, but does not harden. This allows repairs and pin replacements when required.

Figure 2: Incorrect use of permanent epoxy

Check all new 37C "A" cables sent to TESCO Business Units in the last year that have not yet been used. Once informed of the quantity required TESCO will arrange for replacement cables to be sent in exchange for the non-conforming cables, which will be sent back to the vendor for repair. If this arrangement does not prove to be cost effective, alternative arrangements will be made where the local service facility will complete the repair and replacement parts will be sent to accomplish the job.
