Model: TM80/TM100

Product Bulletin # TM-033 Rev 1

Tong Valve Bracket Improvement

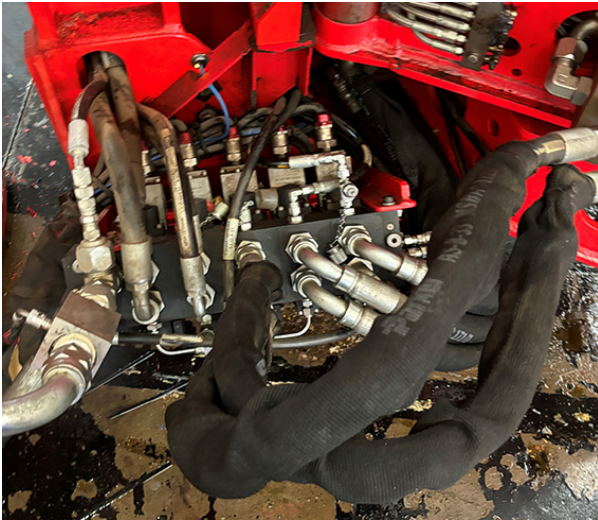
On some Canrig Torq-Matic™ Wrenches, the end of the mounting bracket where the tong valve bolts may break off and/or the mounting hardware for the tong valve assembly may break due to vibration resulting in damage to the valve bank. A new mounting bracket has been designed to support the valve bank from below, taking the strain off the mounting hardware. This new bracket will significantly reduce failures and minimize damage to the valve bank if the mounting hardware fails.

Figure 1: Current tong valve assembly

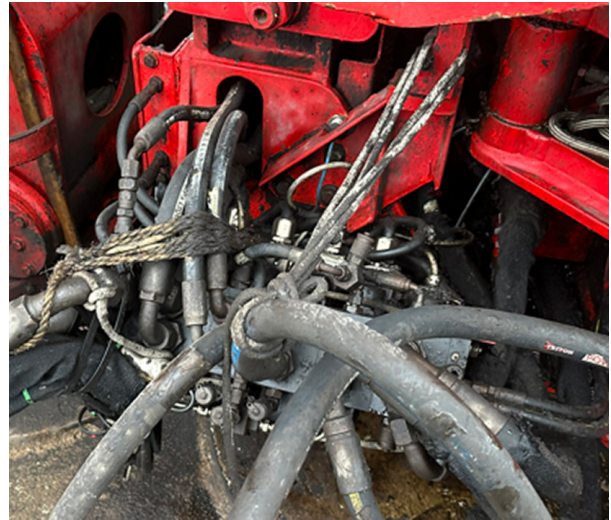
Figure 2: Tong valve assembly after failed mounting hardware

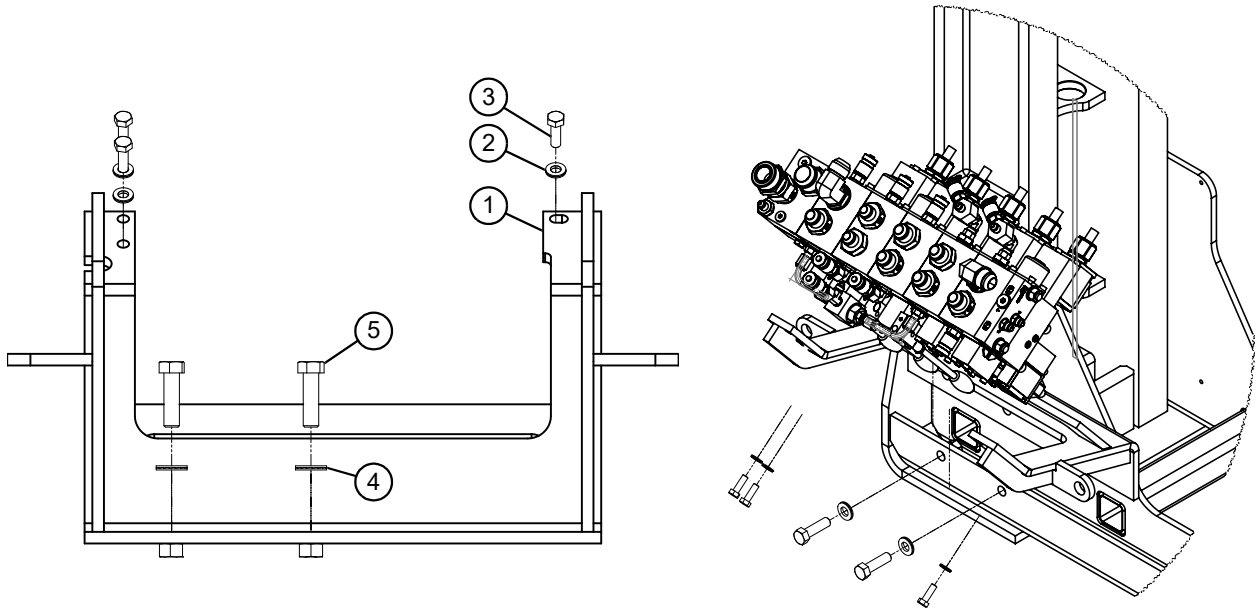
Figure 3: New support bracket design as shown

If you decide to install the revised bracket mount on Wrench models TM80/100, order the kit (Canrig P/N: AY25947) including the new bracket and required mounting hardware.

2. Remove hoses from the valve bank, if necessary. Remove the valve bank from existing support brackets and then remove existing support brackets from the frame.
3. Install the new bracket to the frame using items 4 and 5, as shown in Figure 3 on page 3.
4. Install the valve bank to the new bracket using items 2 and 3, as shown in Figure 3 on page 3.
5. Reconnect hoses to the valve bank, if removed on step 2.
6. Remove LOTO.

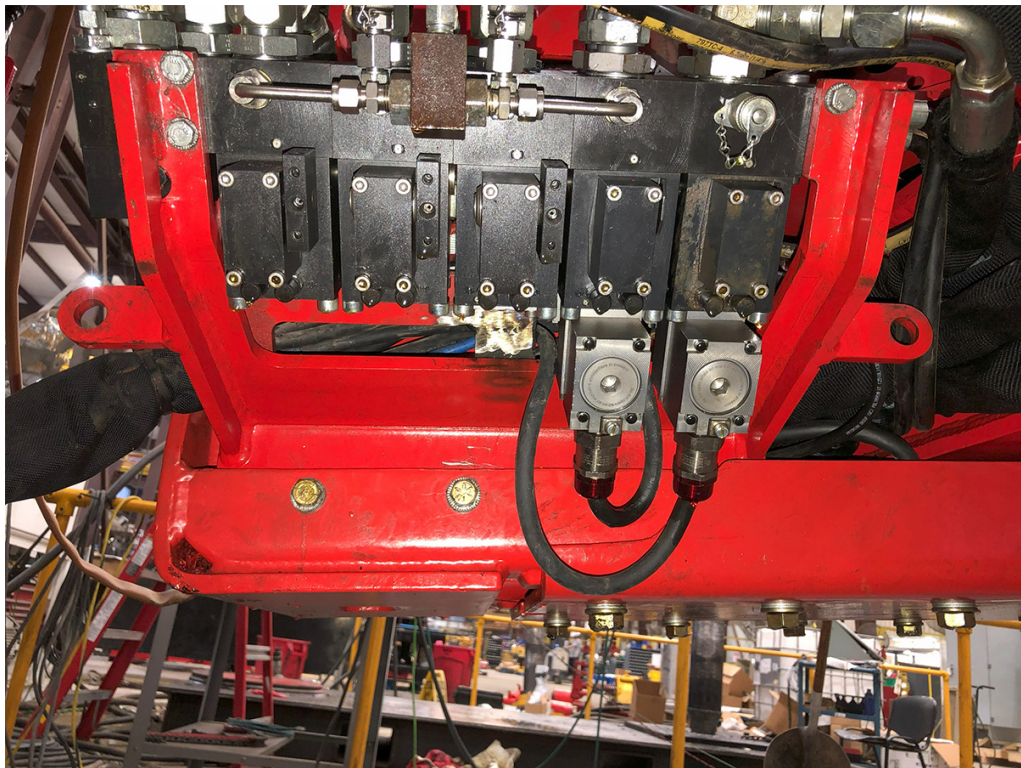
Figure 4: Modification of valve assembly bracket
