PRODUCT: TM-80

DATE: May 18, 2011

Inspection of Vertical Lift Channel

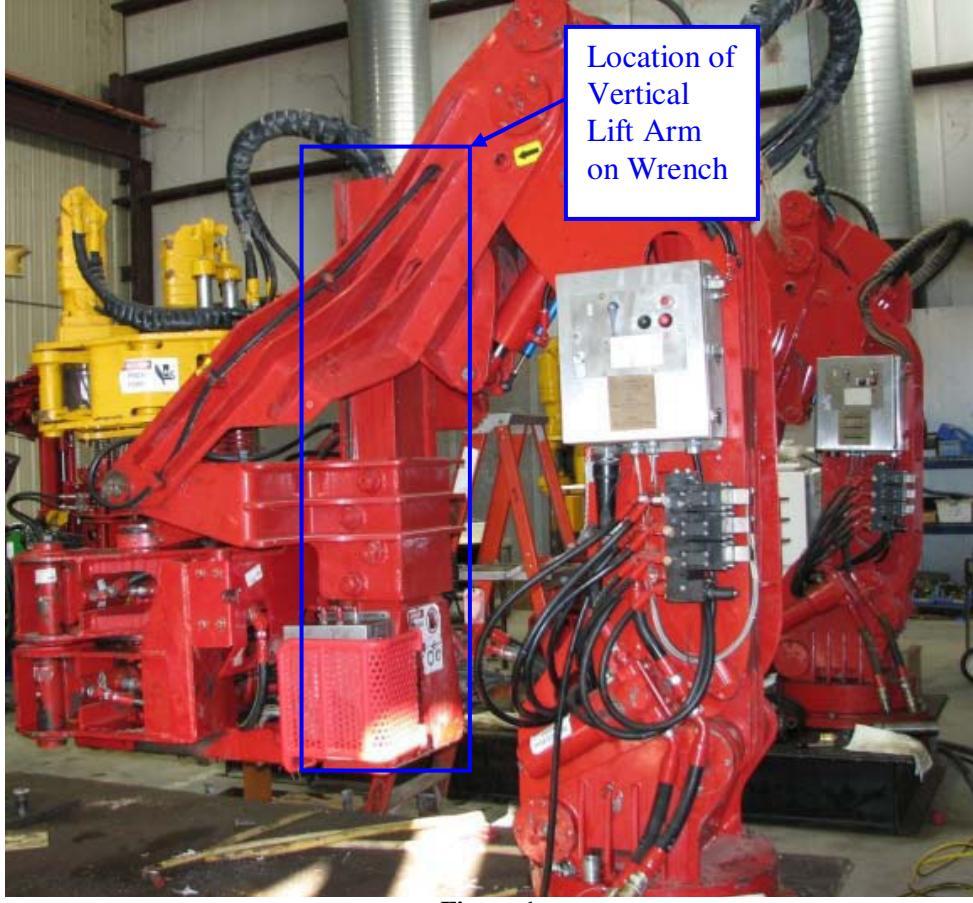
In a few isolated instances, rig crews have discovered cracks in the Vertical Lift Channel located approximately one third to halfway from the base of the channel. Probable cause of these cracks is most likely a result of repeated excessive loading or a singularly large impact load beyond normal operation of the wrench.

Figure 1 and Figure 2 indicate the areas of inspection for cracks on the Vertical Lift Channel.

- 1. Conduct inspection of the wrench following the steps outlined below.
 - a. While the wrench is in or close to the park position, fully raise the Vertical Lift Assembly
 - b. Disconnect power and follow local lock out and tag out procedures and remove any valve hand controls if installed.
 - c. Inspect the upper half of the Vertical Lift Channel for any sign of cracks. Clean the area in the channels for greater visibility if necessary.
 - d. Reconnect power to the wrench to move the assembly so that the bottom half of the Vertical Lift Channel can be inspected.
 - e. Extend the wrench out far enough so that the vertical can be fully lowered down and carefully set on the floor, without putting stress on the vertical cylinder.
 - f. Disconnect power. Follow local lock out and tag out procedures.

- g. Inspect the bottom half of the Vertical Lift Channel for any signs of cracks. Clean the area in the channels for greater visibility if necessary.
- 2. If you find evidence of cracking, as shown in Figure 3, contact the Canrig Service Support Department immediately for an assessment. Contact information is provided below.

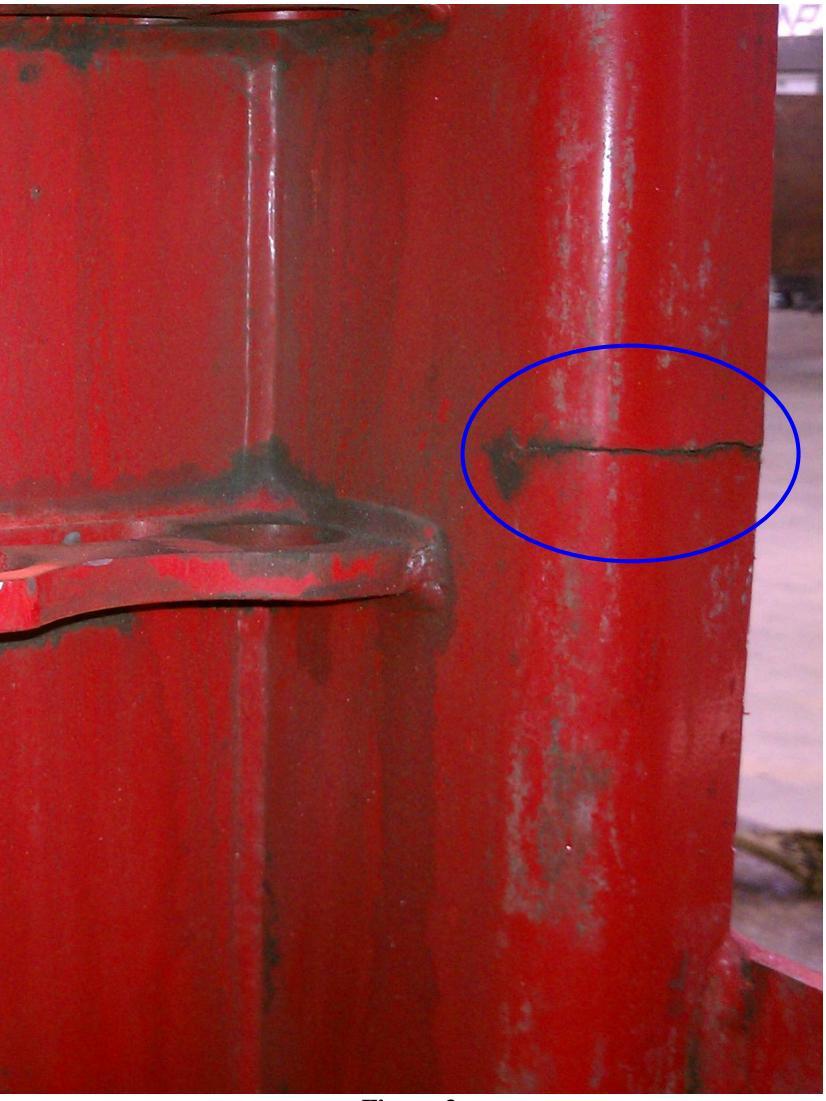
3. Failure to identify the problem and have it promptly corrected could potentially damage the equipment and, if not dealt with, could potentially become a hazard to personnel.
