<b>Safety/Technical Bulletin</b>			  <p>Tesco Corporation 3993 W. Sam Houston Pkwy N., Suite 100 Houston, Texas 77043 Tel: 1-877-TESCO-77 (North America) Tel: (713) 359-7295 (International) Email: <a href="mailto:bulletins@tescocorp.com">bulletins@tescocorp.com</a> <a href="http://www.tescocorp.com">www.tescocorp.com</a> <a href="http://www.tescoparts.com">www.tescoparts.com</a></p>
<b>No: SB053</b>	<b>Rev: 0</b>	<b>Date: 09 February 2011</b>	
<b>Internal Casing Drive System (ICDS) 4-1/2" and 5-1/2"</b>

**ATTENTION ALL CUSTOMERS / RENTERS / USERS OF**  
**TESCO Internal Casing Drive Systems (ICDS)**

**THIS BULLETIN CONTAINS IMPORTANT SAFETY AND TECHNICAL INFORMATION CONCERNING  
THE POTENTIAL OF DROPPING A CASING STRING WHILE USING THE ICDS TOOLS**

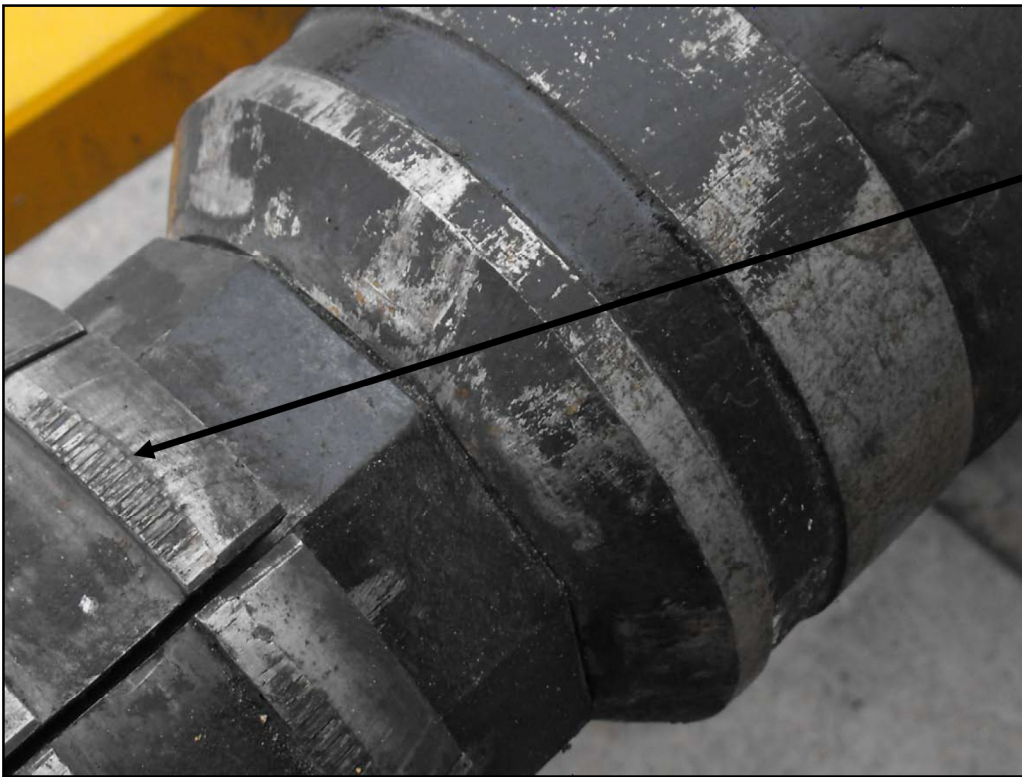
Figure 1 - Close Up View Of ICDS Grapple Tips

Figure 1 and Figure 2 show some of the tell-tale signs of poor radial loading by the ICDS tool against the inside diameter of the casing pipe. Figure 3 is a layout of the tool and casing Inner Diameter (ID) and Outer Diameter (OD).

Signs that the grapples have slipped inside casing.

1. Immediately stop usage of both 4-1/2" and 5-1/2" ICDS tooling.
2. Ensure that all ICDS tooling (TESCO Part # 860142 and Part # 860147) are segregated so they are not accidentally used.
3. As an alternative to using the 4-1/2" and 5-1/2" ICDS tooling, use the TESCO External Casing Drilling System (ECDS) tools.

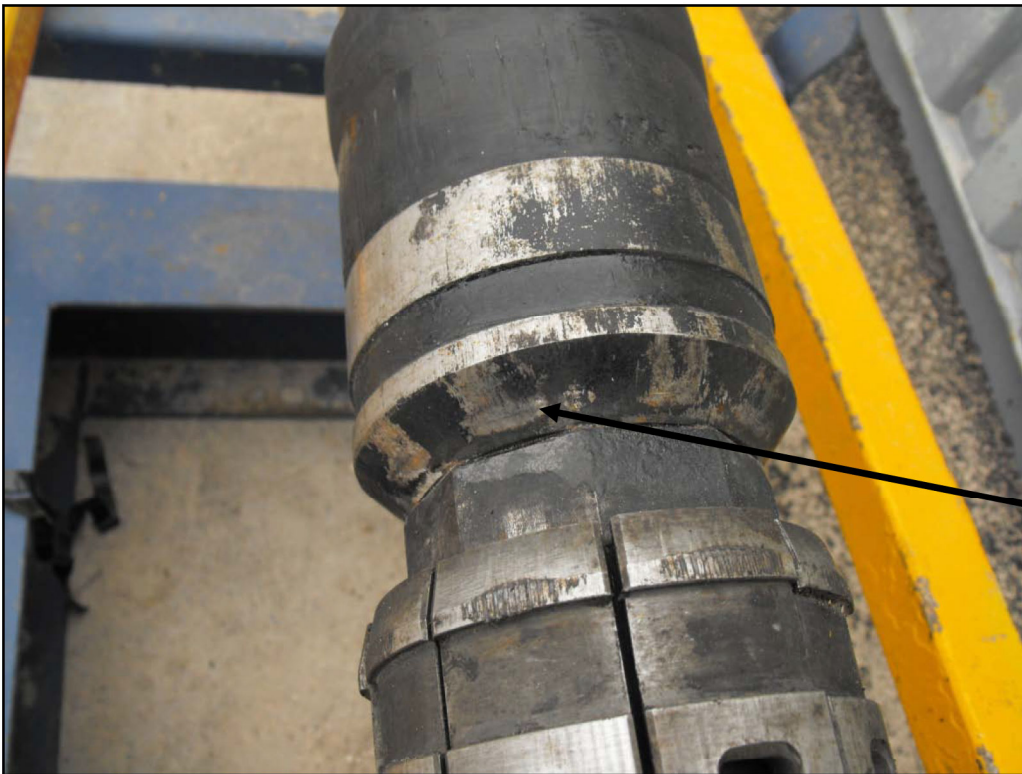
Figure 2 - Close Up View Of Packing Cup Seat

Signs of multiple impacts of the grapples at the end of the tool stroke. End of stroke impacts are an indicator of poor radial loading by the tool.

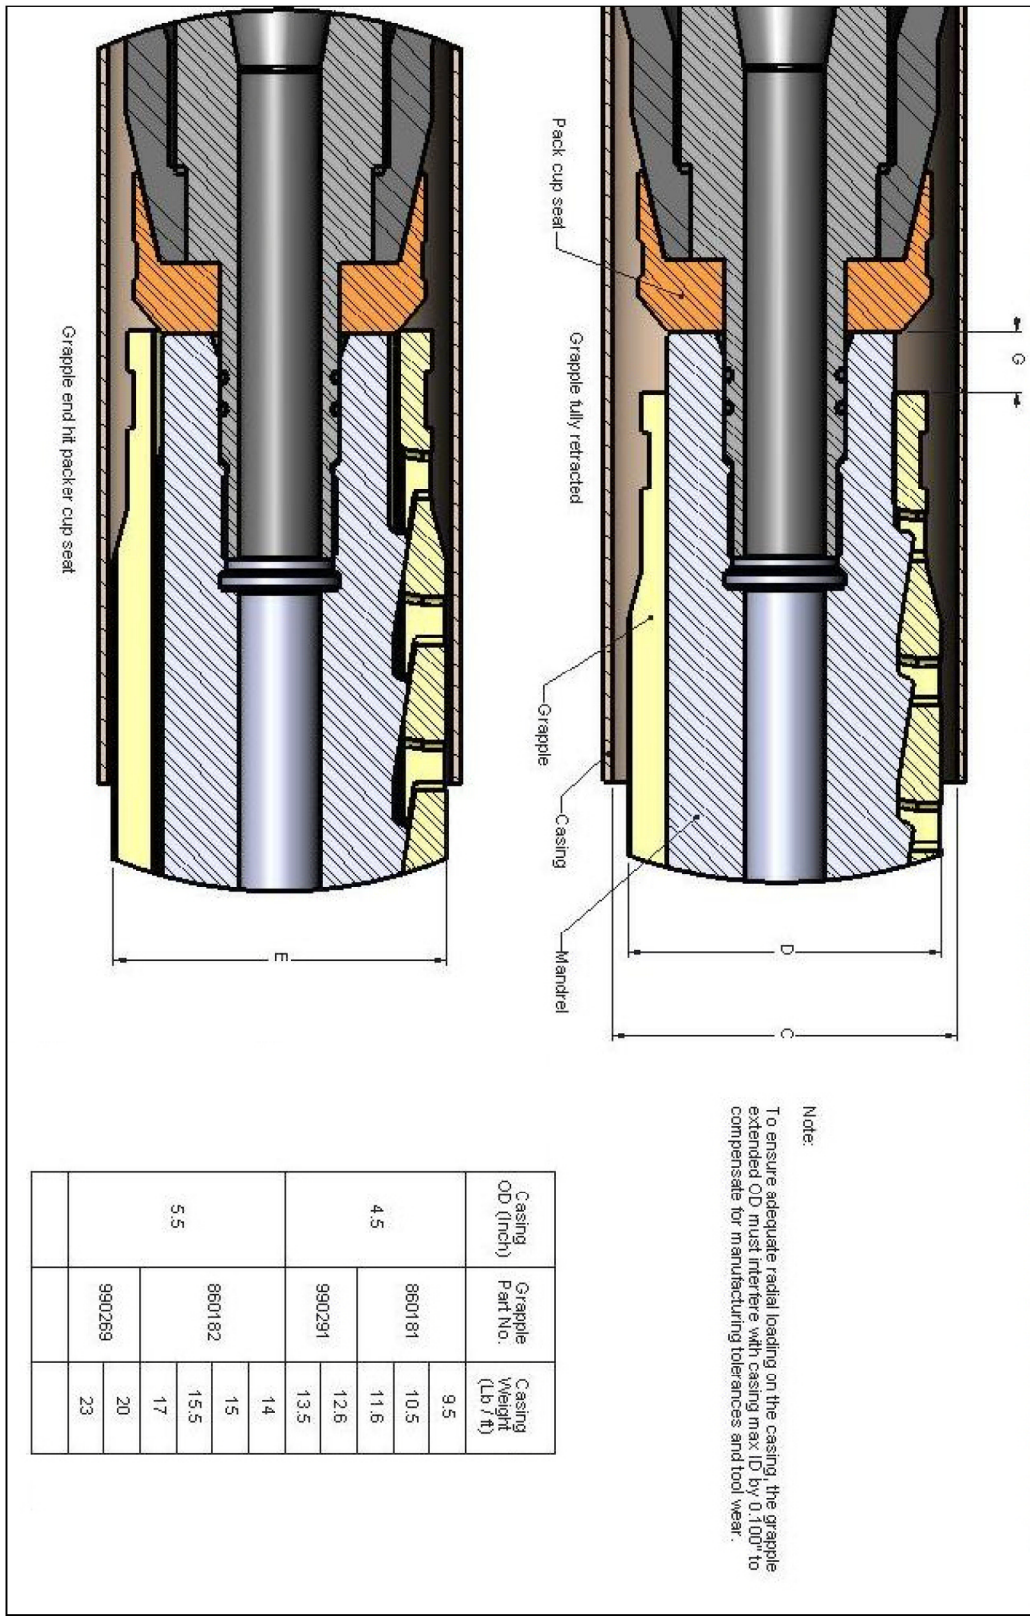
Figure 3 – Section View of ICDS Tooling

Due to the tolerance range of the casing ID and the wear on the tooling, the ICDS tools may not fully engage the casing with enough radial force to hold the full load of the casing string. There is a moderate to high risk, with some tool and casing combinations, that casing strings will be dropped. In some extreme scenarios, even a single joint of casing runs the risk of being dropped.
