<b>Technical Bulletin</b>		
<b>No: TB075</b>	<b>Rev: 0</b>	<b>Date: 10Feb2010</b>
<b>Elevator Link Bushing Upgrade 150T-EMI-400 Top Drive Systems</b>

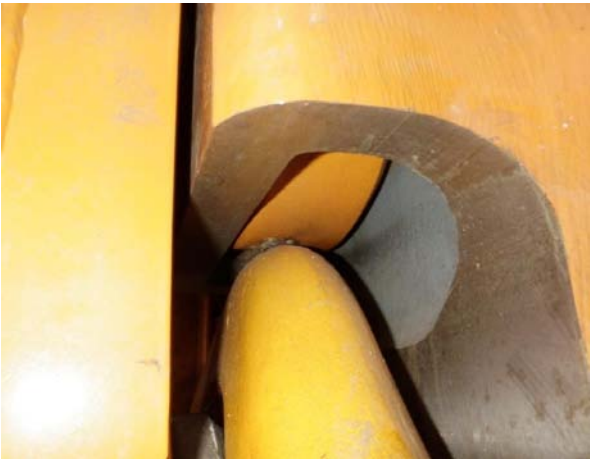
TESCO Engineering and the Quality Control department have carried out an investigation and identified incidents in the field where the current 150T-EMI-400 elevator link-tilt design (Figure 5) permits the elevator links to make contact with the gearbox/swivel and split block adapter during top drive operation (Figure 1). This results in the gradual wear to the components (Figure 2).

**Figure 1:** Elevator link in contact with gearbox and split block adapter

Visually inspect the gearbox and split block adapter for any wear. TESCO personnel can assist in identifying acceptable wear limits. TESCO Business Units and customers operating the TESCO 150T-EMI-400 Top Drive System are encouraged to upgrade their units to the new elevator link bushing design. The elevator link bushing design can be obtained through TESCO AMSS.

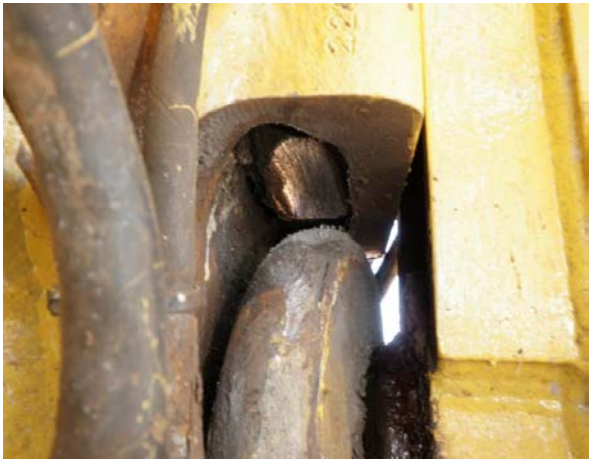
**Figure 2:** Wear evident on split block adapter as a result of continuous contact with elevator link

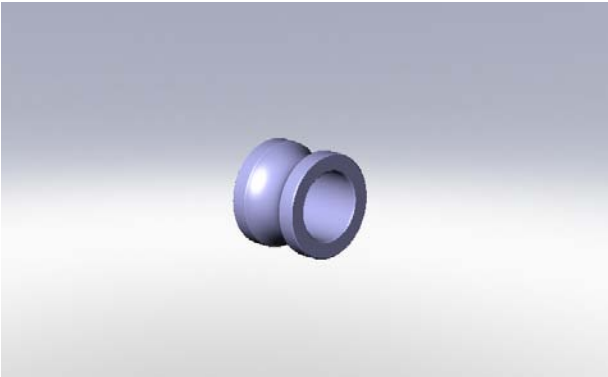
**Figure 3:** Elevator link bushing currently used

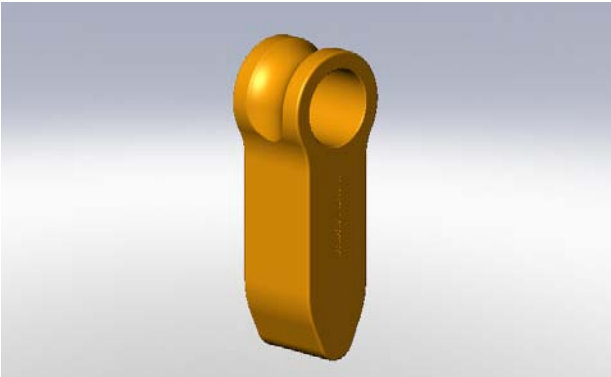
Although this will not immediately jeopardize the integrity of the top drive unit or affect the critical load path, TESCO has developed a new elevator link bushing (Figure 4) that ensures top drive operation will not be disrupted as a result of wear. The new elevator link bushing design restricts vertical movement of the elevator links (Figure 6), preventing them from coming into contact with the gearbox/swivel and split block adapter.

**Figure 4:** New elevator link bushing

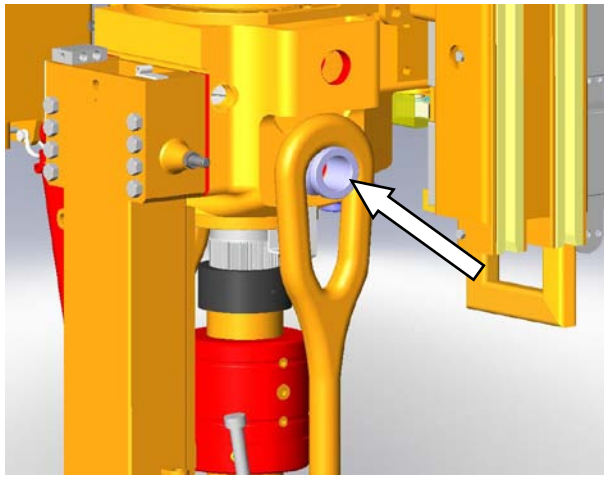
**Figure 5:** Current elevator link bushing design allows excessive vertical link movement (split block adapter not shown for clarity)

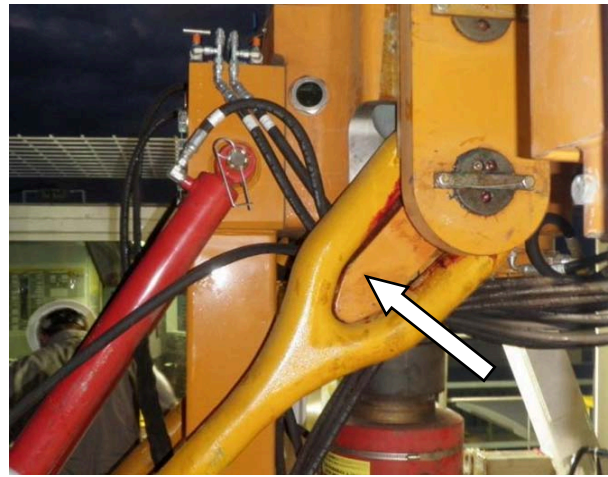
**Figure 6:** New elevator link bushing design limits vertical elevator link movement
