Model: T-Series Top Drives Serial #: N/A	Oct. 30, 2024
Product Bulletin # TDS-258 Rev 1

## Grabber Clamping Box Inspection

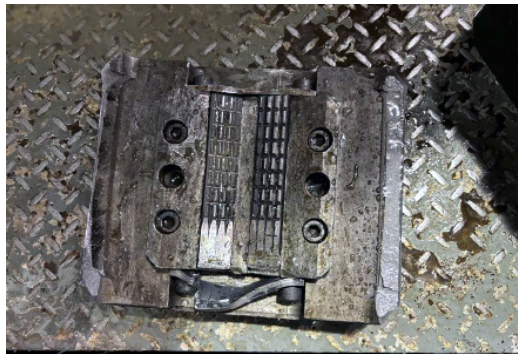
Figure 1: Damaged Grabber Die Holder Plate

Canrig was made aware of an incident wherein the grabber die holder plate separated from the grabber clamping box after the grabber was forced away from the grabber leg whilst torquing. Canrig recommends inspection as a precaution to prevent a dropped object incident.

Canrig recommends customers to replace the affected part numbers in **Table 1** with new part numbers in **Table 2**.

Canrig recommends inspecting the grabber clamping box including welds and replace the part if cracks or signs of damages are present.
